Town of Blind River

Automated Drinking Water Well Waste Reduction System

Project Final Report

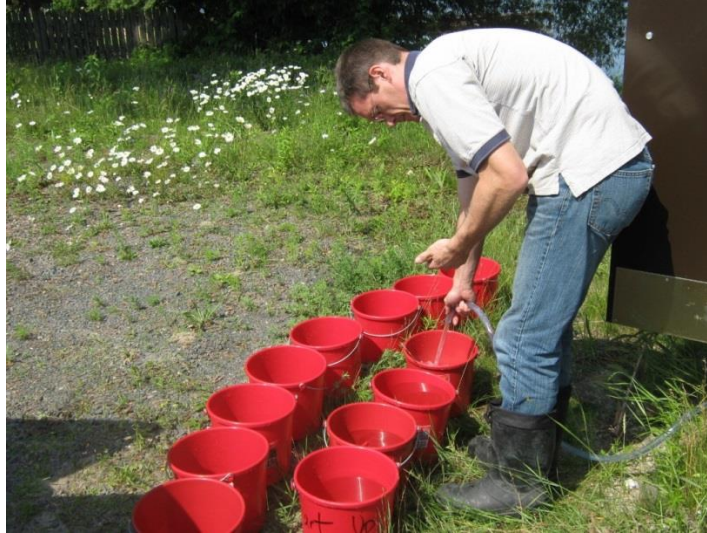
Interval sampling of raw water from well #6

The first step in the project was to determine the appropriate water quality parameter to monitor and to select the well which would be used for testing the equipment. The specifications for the equipment were developed simultaneously. Water quality sampling was conducted in the summer and fall of 2012 on the 4 service wells to determine which well displayed the poorest initial water quality on start-up. Sampling was conducted by starting each well following shut-down periods established by the drinking water system operator, (dictated by the drinking water demand and available system storage for treated water). Each well was started and a sample aliquot immediately directed from a small diameter hose connected to the well discharge into a series of 5 gallon pails. The second sample was directed to second pail 15 seconds after the first, etc. Following the filling of each pail, tests for turbidity, UVT and conductivity were conducted using hand held water quality analyzers. These results were recorded in the field, (the photos below show the sampling and field testing procedures).

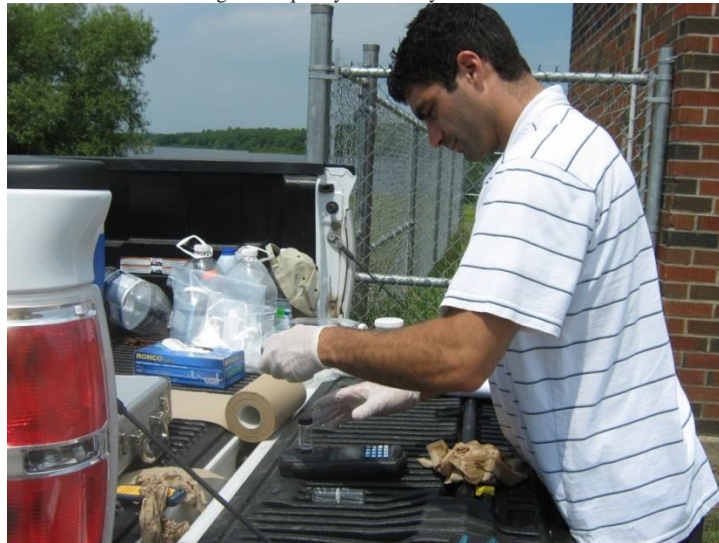
Technician conducting water quality field analyses

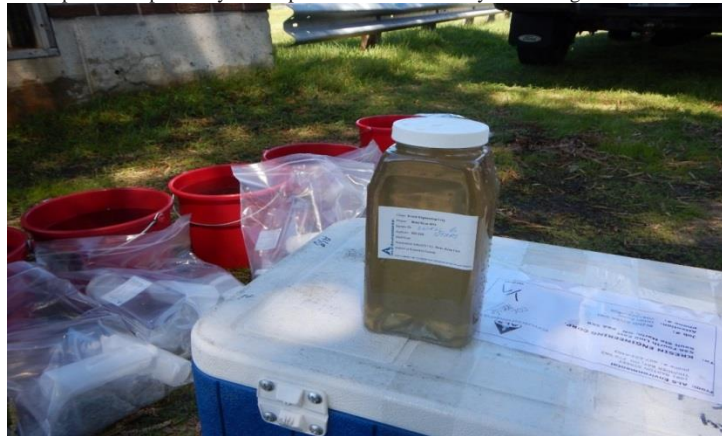
Prepared sample ready for shipment to the laboratory for testing

Samples were drawn into laboratory supplied bottles from each of the sample pails from each well series and were packaged and shipped by bus to ALS laboratories in Thunder Bay, ON for further analyses.

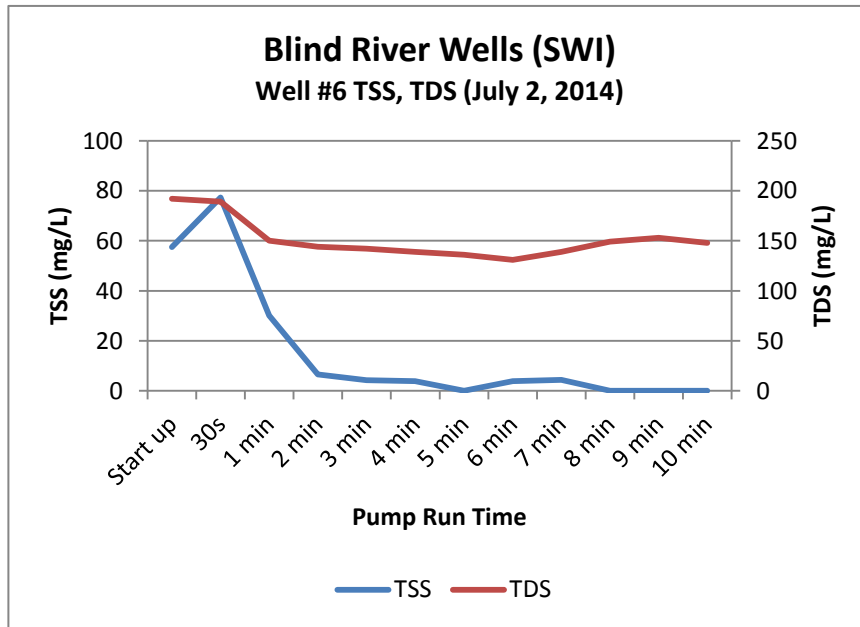
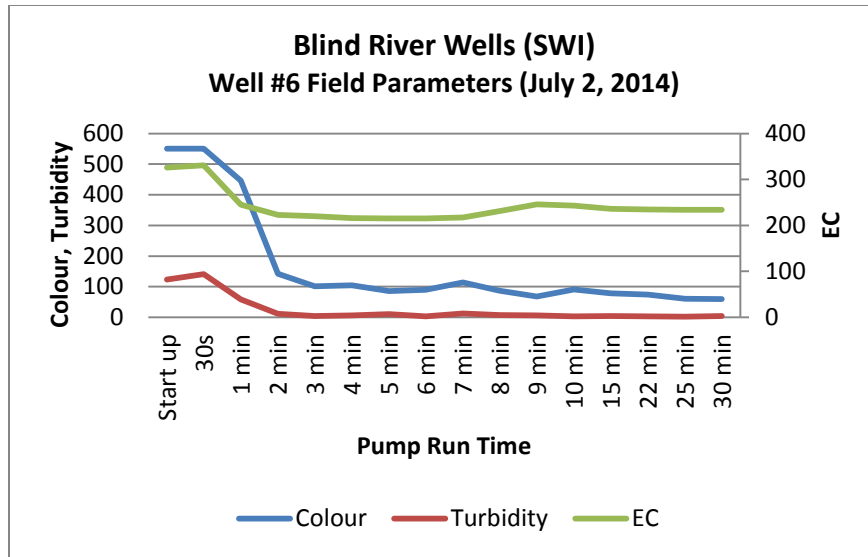
Plots of result of samples following varying time intervals

Note: graphs shown for both total and dissolved iron and manganese

It was determined that the initial quality of the raw well water varied with subsequent sampling runs. Sampling results confirm a marked improvement in water quality, after approximately 4 minutes on average, and that there was little further improvement after this pumping time. From review of the initial data set, iron, TSS and colour were identified as preliminarily preferred candidates for monitoring to control the automated valve system.

Since colour can be readily monitored it was decided to use this parameter for monitor and control of the valve actuators. This was supported by a review of available and affordable on-line monitoring equipment. The plots below display the sample period and the corresponding analytical results.

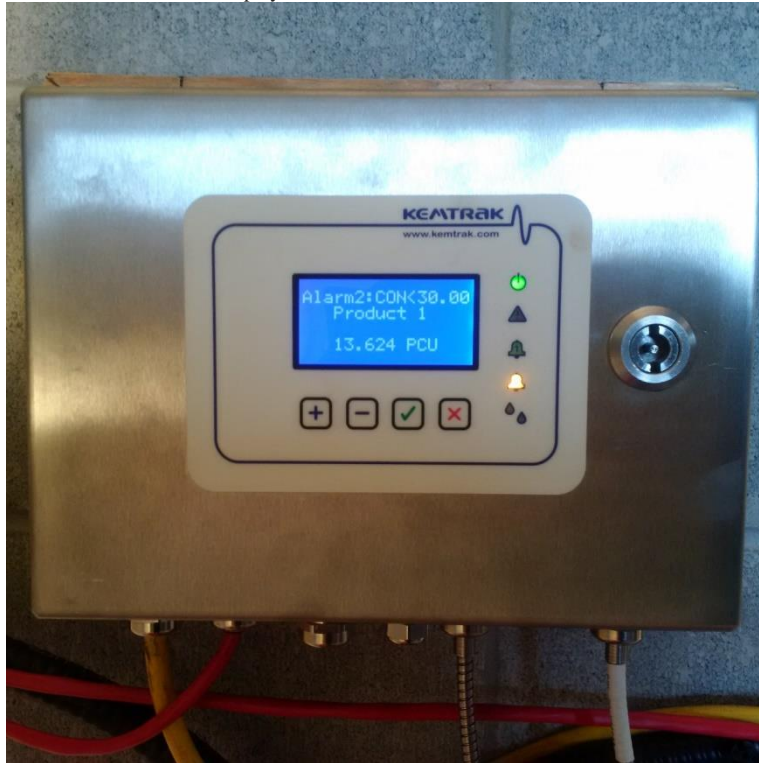
Kemtrak controller display

3. When the pump switches on, the analyzer also switches on and initializes.
4. For testing purposes a colour set point of 14.5 PCU was used. Once the analyzer initializes and begins to analyze colour and once the raw water colour was consistently below 14.5 PCU for a period of 10 seconds (“Delay”), the unit sent the appropriate signals to close the waste valve and open the main valve to direct raw water to the treatment plant.

A time period of 10 seconds was used for the “Delay” and “Hold” parameters only for testing purposes and these values were changed to 30s (Delay) and 300s (Hold) once testing was complete. This was done to avoid frequent diversion of pumping to waste while at the same time maintain water quality at a level that the treatment plant can effectively accommodate.

A set point of 14.5 PCU was also only used for testing purposes and this value is felt to be too low as a working set point. Accordingly, the set point was set at 30 PCU once testing was

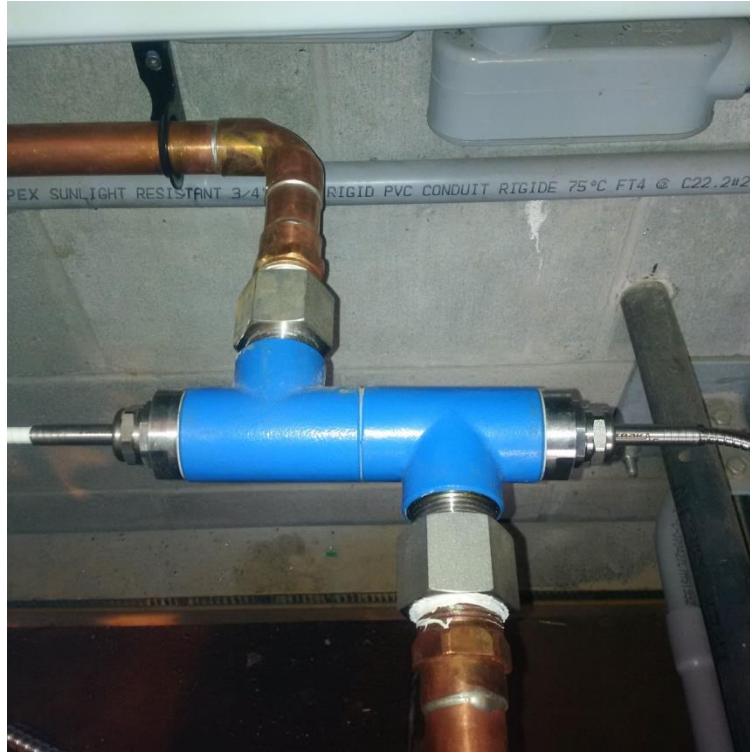
The in-line colour sensor flow cell

Since the initial raw water quality is so poor it became apparent that the sensitivity of in-line monitor sensors was being reduced with time due to the deposition of fines in the raw water and that the glass lenses were becoming occluded. Due to budget constraints and time remaining to complete the project it was not possible to order, install and test the cleaning kits supplied by the manufacturer. This would be an area for future testing of the monitoring unit.
