**THE CORPORATION OF THE  
TOWN OF BLIND RIVER**

**REQUEST FOR PROPOSAL FOR  
WELL REHABILITATION 2023**

**CONTRACT NO. 23-0803**

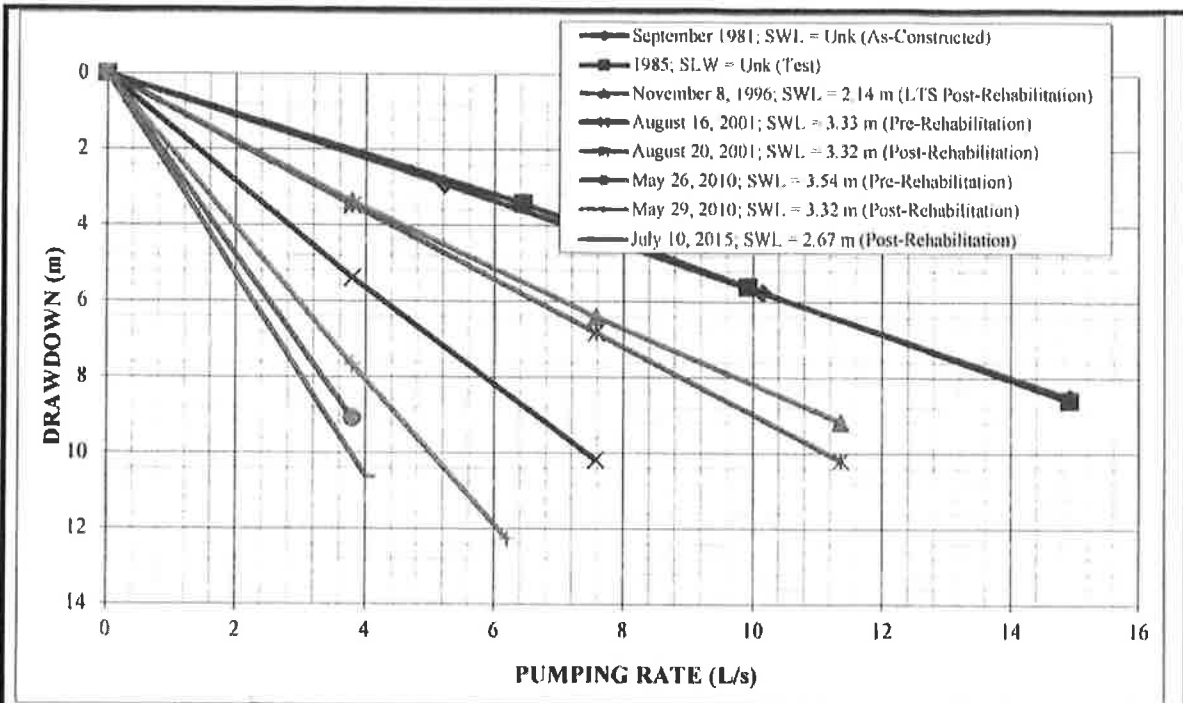
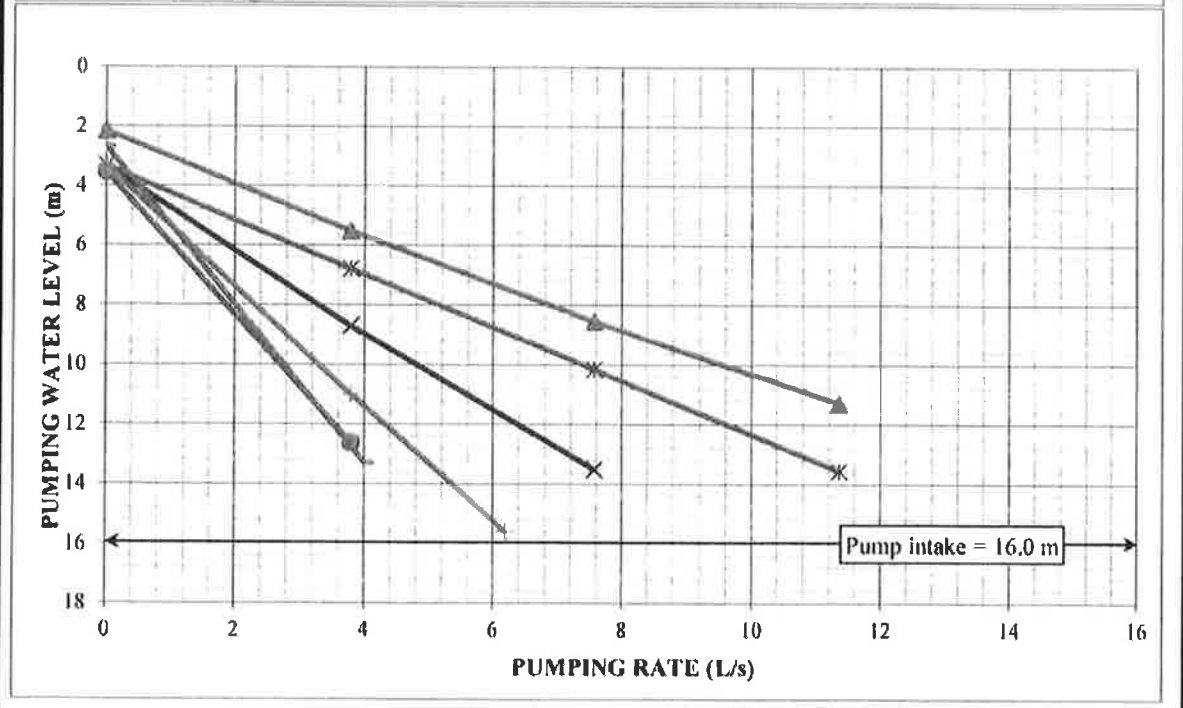
Lotowater Technical Services Inc. Figure 1

**Notes:**  
 All water levels are referenced from top of casing  
 Top of casing = 0.21 m above floor

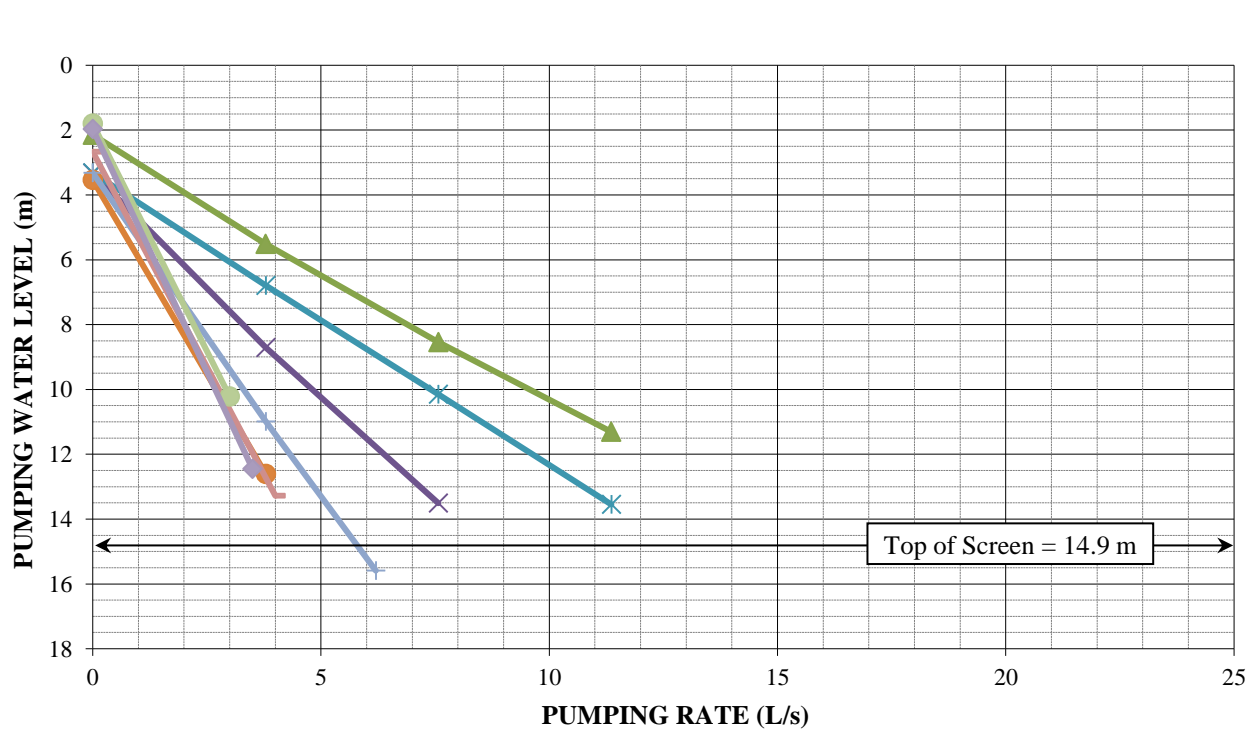
<b>Town of Blind River</b>	
<b>Well #6</b>	
<b>Comparison of Variable Rate Tests</b>	
<b>Lotowater Technical Services Inc.</b>	<b>Figure 1</b>
Reference: 184-013	2019-06-10

A post-rehabilitation variable rate well performance test was conducted on June 12, 2019. The data collected is provided in **Table 3** and was plotted graphically and compared against historical pumping levels on **Figure 1**. The post-rehabilitation test results indicate well performance has not improved the wells' capacity. The wells' maximum capacity is still about 4.5 L/s.

**Notes:**  
 All water levels are referenced from top of casing  
 Top of casing = 0.21 m above floor  
 Pump Inlet = 16.0 mbtc

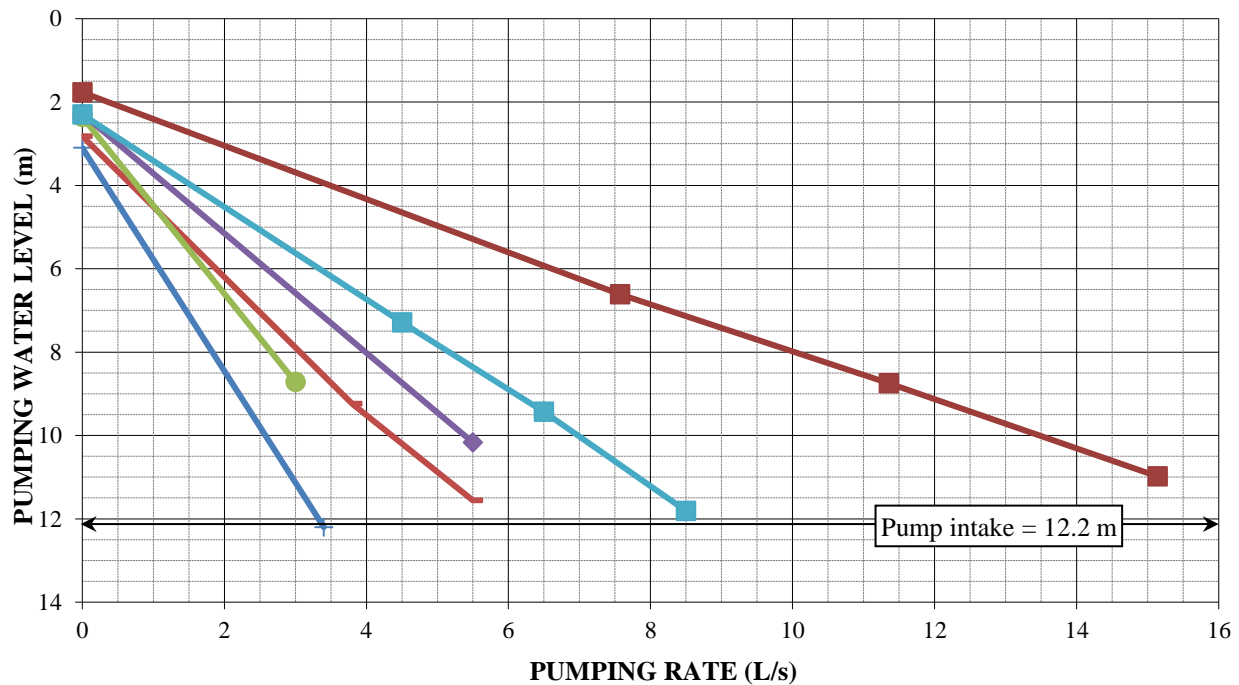
All water levels are referenced from top of casing  
 Top of casing = 0.68 m above ground surface  
 Top of screen = 13.0 m

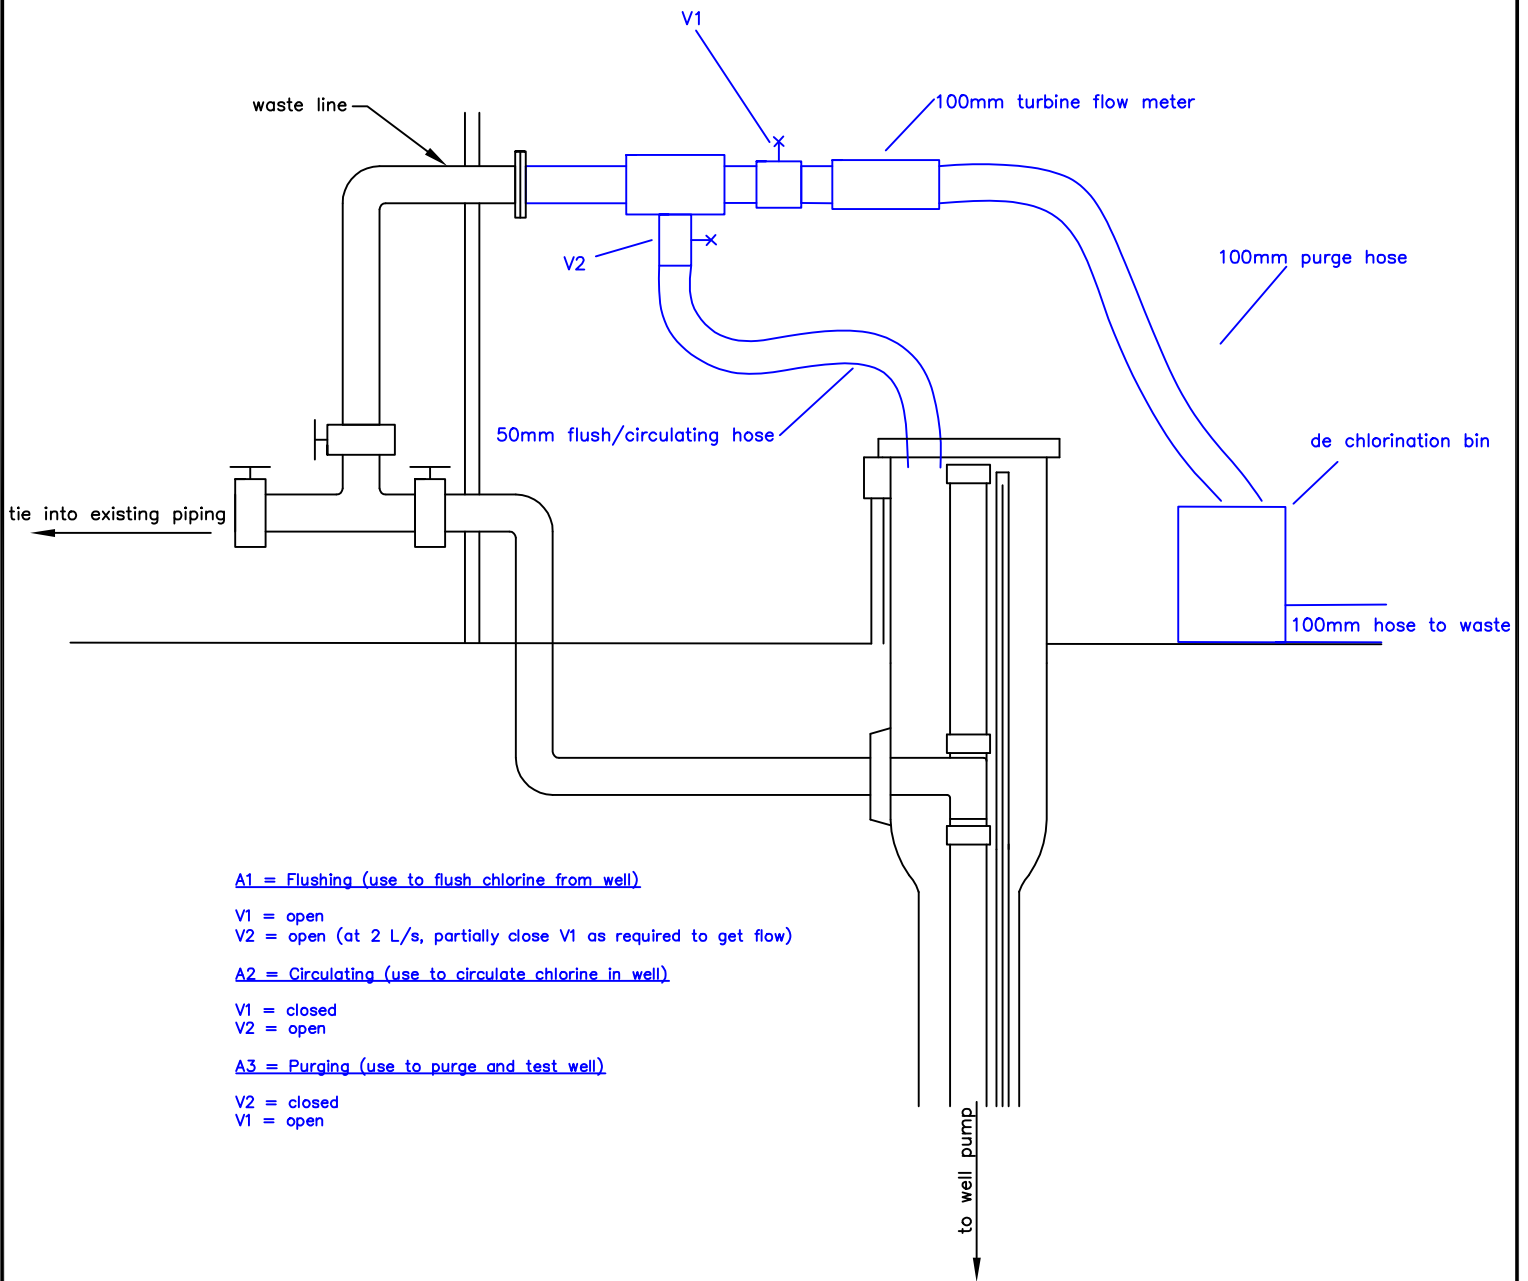
## Temporary Purge/Flush/Circulating Assembly

- A1 = Flushing (use to flush chlorine from well)
- V1 = open
- V2 = open (at 2 L/s, partially close V1 as required to get flow)
- A2 = Circulating (use to circulate chlorine in well)
- V1 = closed
- V2 = open
- A3 = Purging (use to purge and test well)
- V2 = closed
- V1 = open

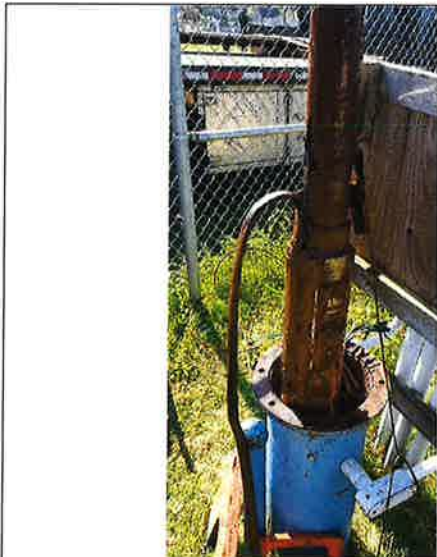
**Photo 5: Pump Removal**

The pumping equipment was removed (**Photos 5 and 6**), cleaned and visually inspected on-site. It was found to be in decent condition for re-installation.

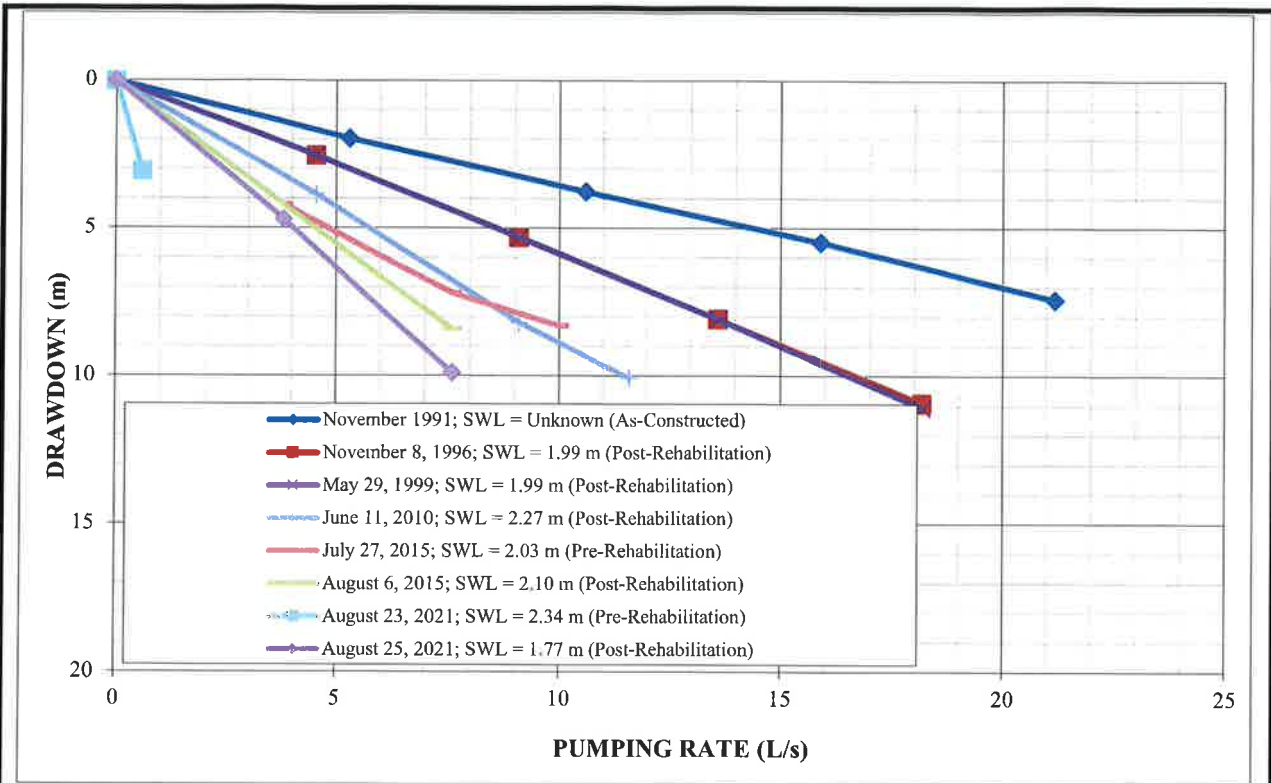
A post-rehabilitation well performance test was conducted on August 26, 2021, at 3.8 and 7.6 L/s. The data collected is provided in **Table 4** and was plotted graphically and compared against historical pumping levels on **Figure 1**. The post-rehabilitation test results indicate well performance has increased when compared to the pre-rehabilitation test.

- All water levels are referenced from top of casing
- Top of screen at 13.3 m below top of casing
- Top of casing = 0.65 m above ground surface
- Pumping duration = 30 minute steps
