## MEMORANDUM

**RE: Offshore Geotechnical Investigation for the New Raw Water Intake Pipe,  
Blind River, Ontario**

## Site Plan

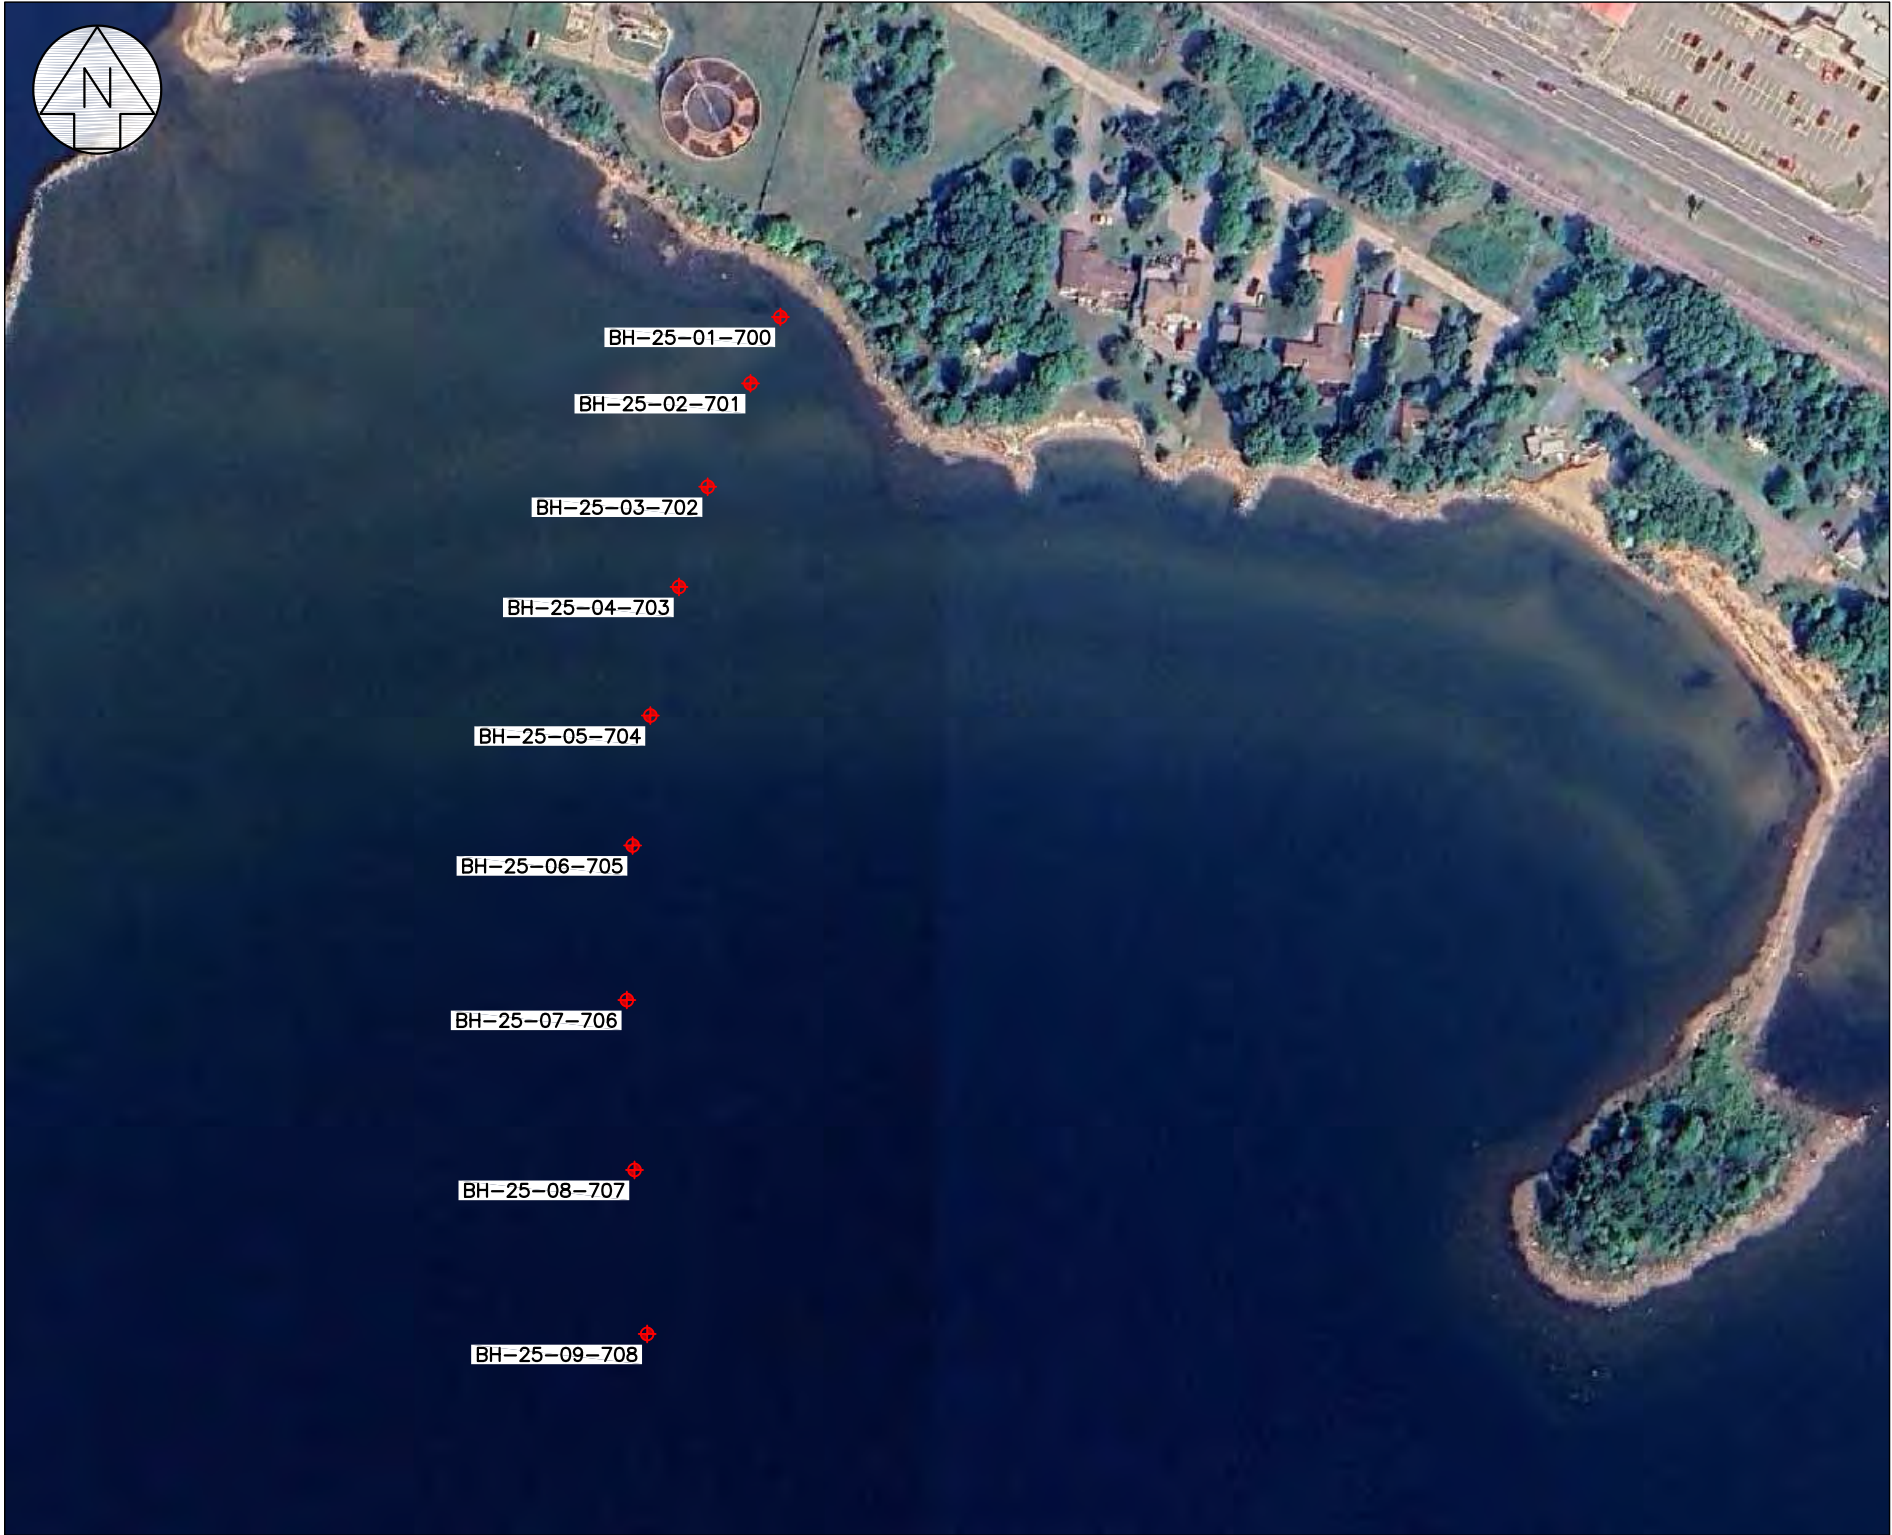
BOREHOLE LOCATION PLAN

COORDINATES		
NAME	EASTING	NORTHING
BH-25-01-700	349 232	5 116 228
BH-25-02-701	349 222	5 116 207
BH-25-03-702	349 207	5 116 174
BH-25-04-703	349 197	5 116 142
BH-25-05-704	349 187	5 116 102
BH-25-06-705	349 180	5 116 060
BH-25-07-706	349 177	5 116 011
BH-25-08-707	349 178	5 115 957
BH-25-09-708	349 181	5 115 905

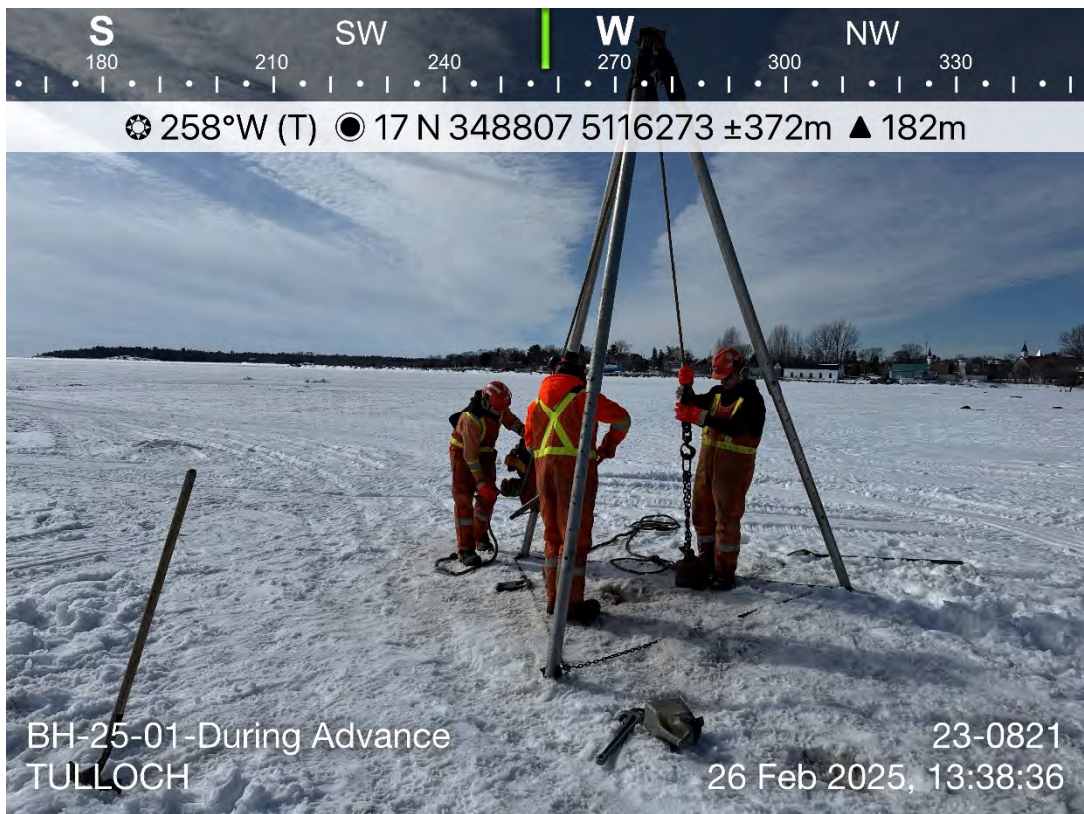
Photo 1: BH-25-01-700 during advancement. Photo taken facing west.

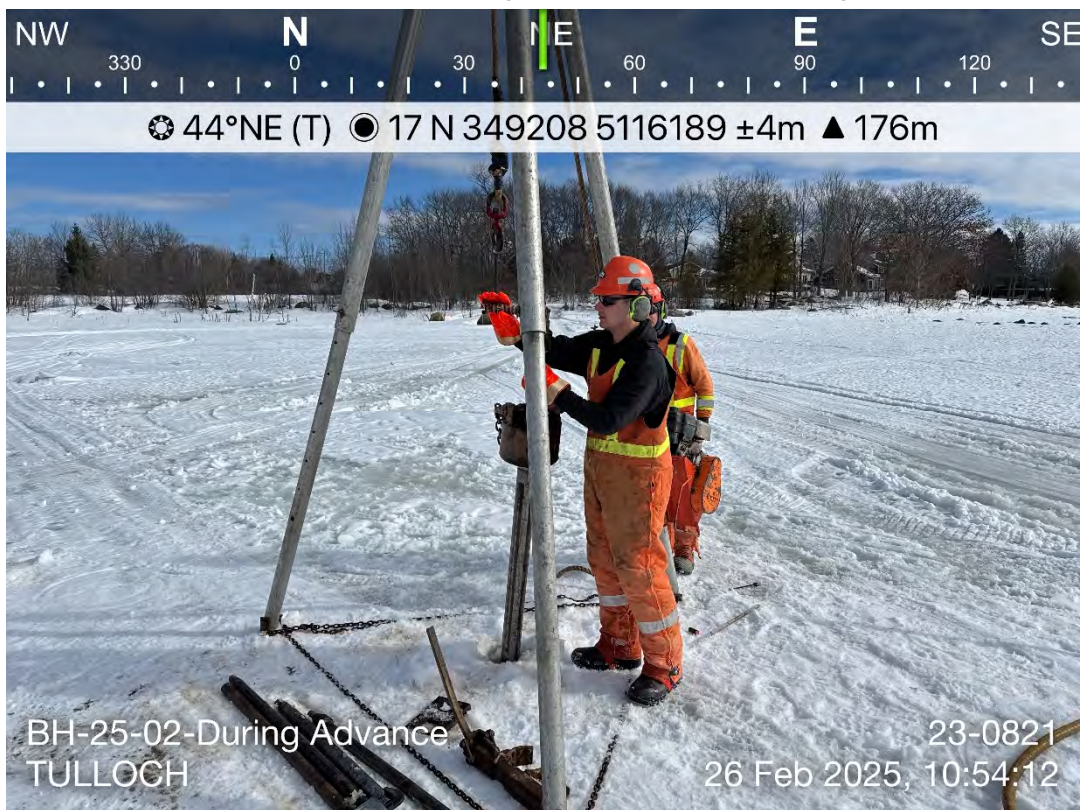
Photo 2: BH-25-02-701 during advancement. Photo taken facing northeast.

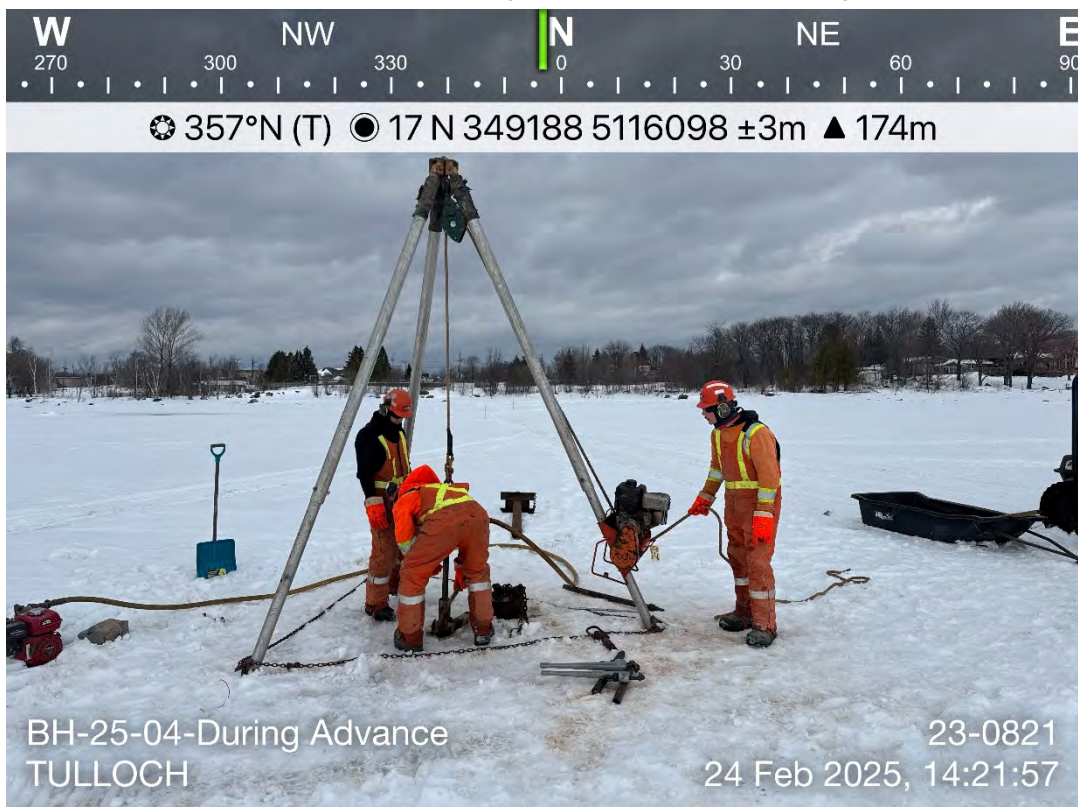
Photo 4: BH-25-04-703 during advancement. Photo taken facing north.

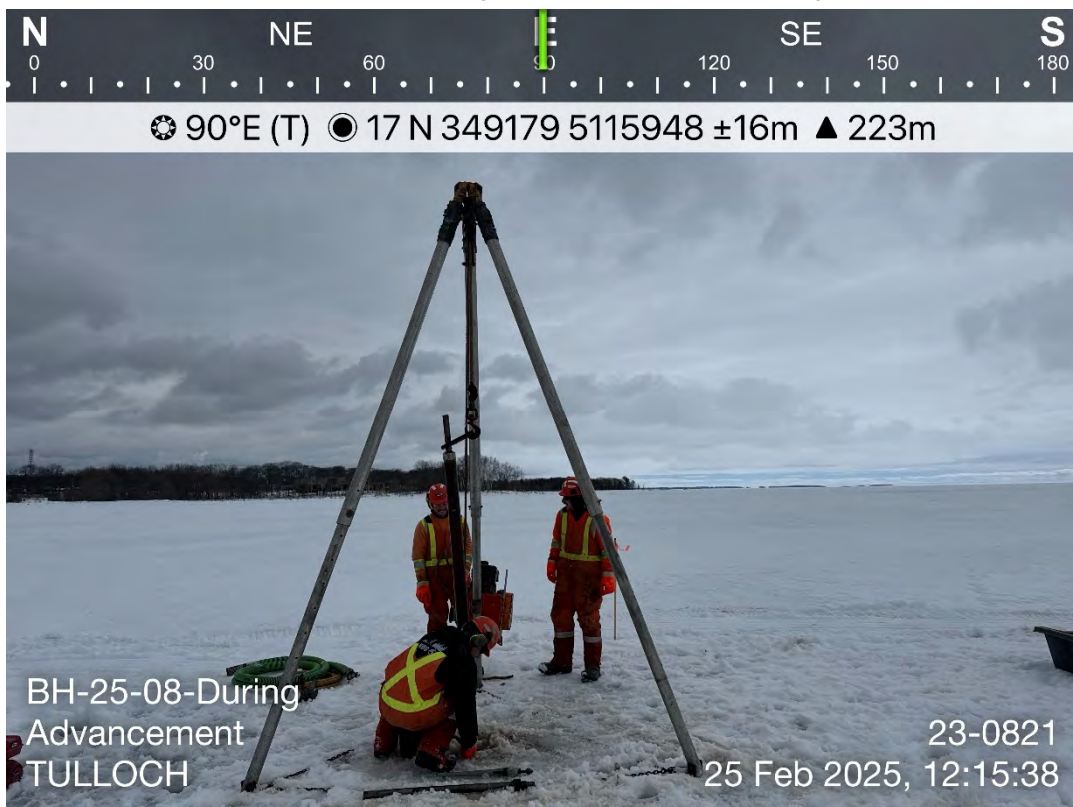
Photo 8: BH-25-08-707 during advancement. Photo taken facing east.

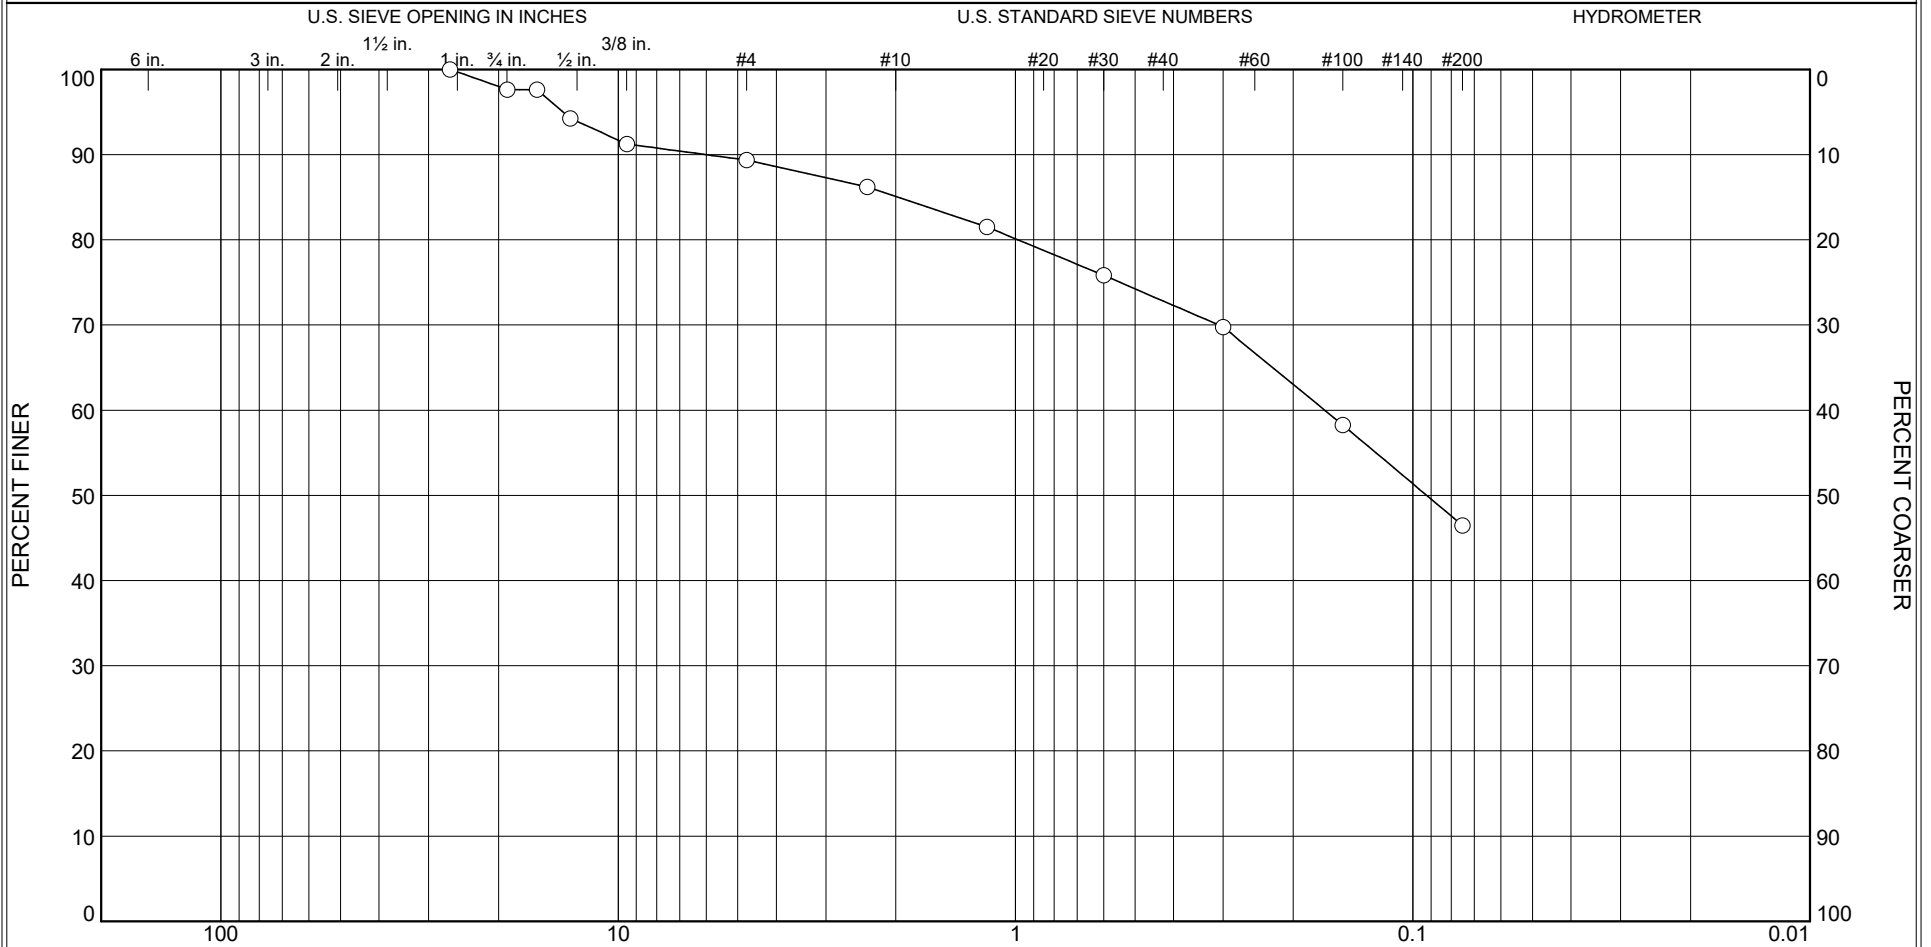
# Particle Size Distribution Report

% +3"	% Gravel		% Sand			% Fines
	Coarse	Fine	Coarse	Medium	Fine	Silt
0.0	2.3	8.3	4.3	12.3	26.3	46.5

Two (2) representative samples were also taken for grain size distribution testing. The grain size distribution of major soil constituents found in the deposit is shown below in Table 4-2. Grain size distribution plots can be found in the laboratory reports attached to this memorandum.
