**THE CORPORATION OF THE
TOWN OF BLIND RIVER**

**REQUEST FOR PROPOSAL FOR
WELL REHABILITATION 2025**

CONTRACT NO. 25-0730

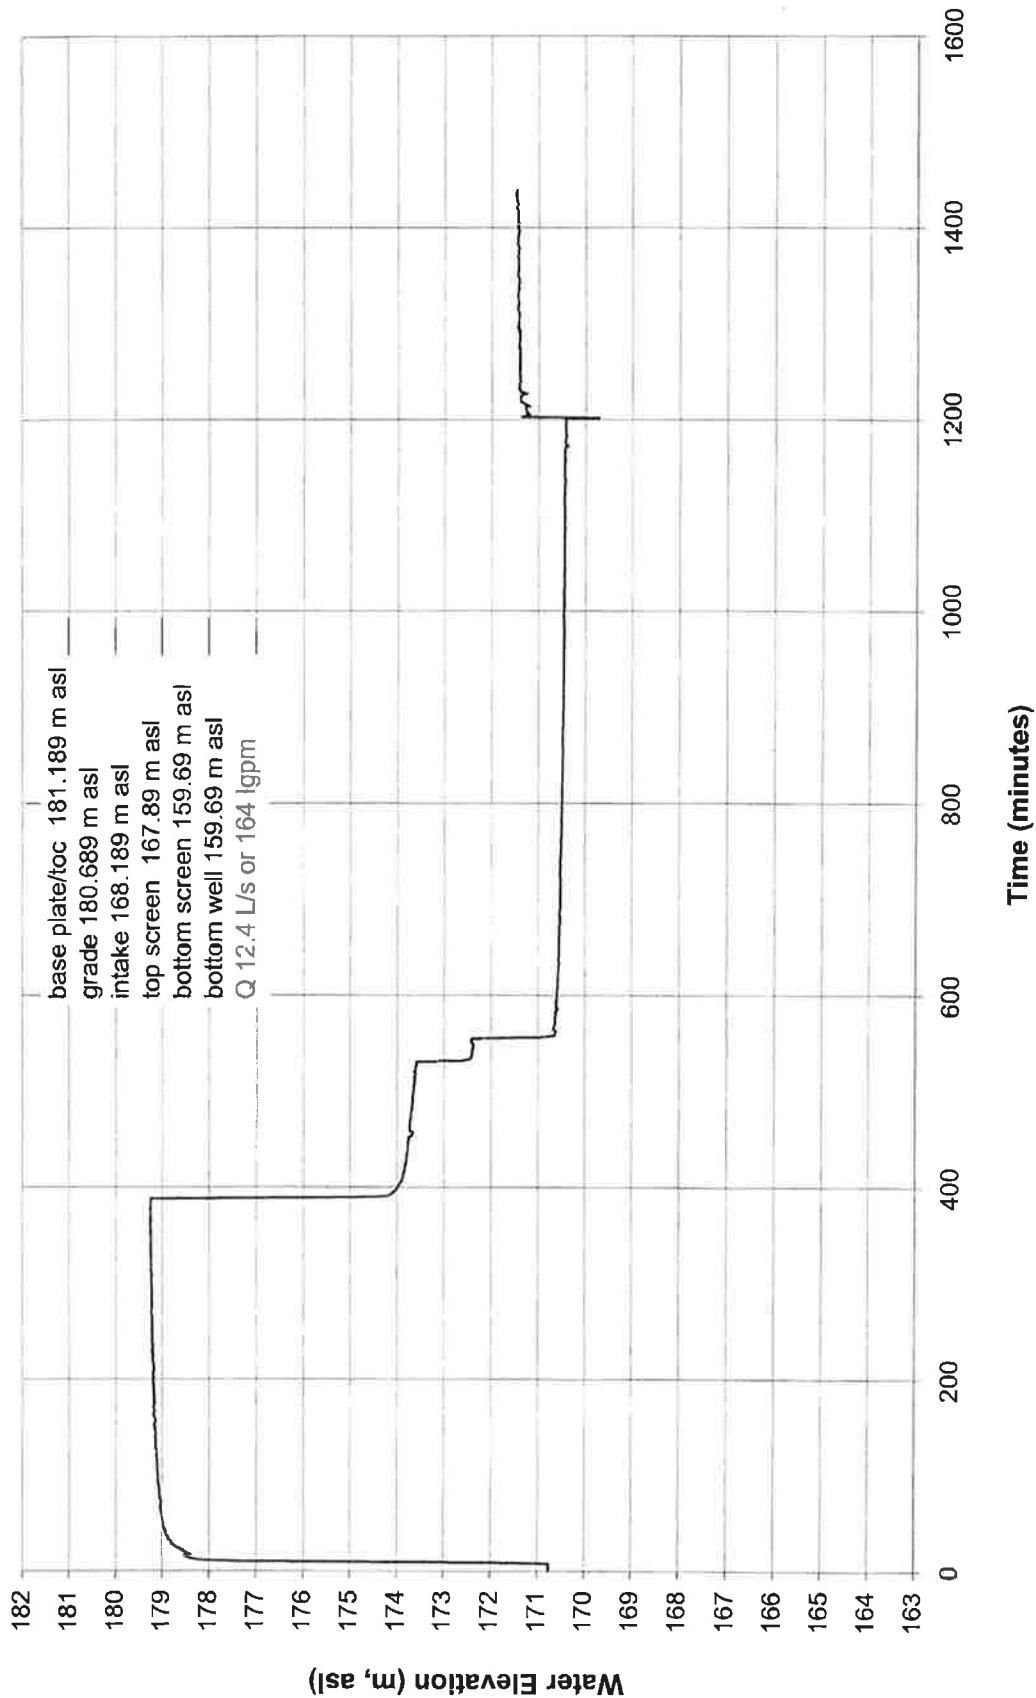
Test Results at Well no. 8

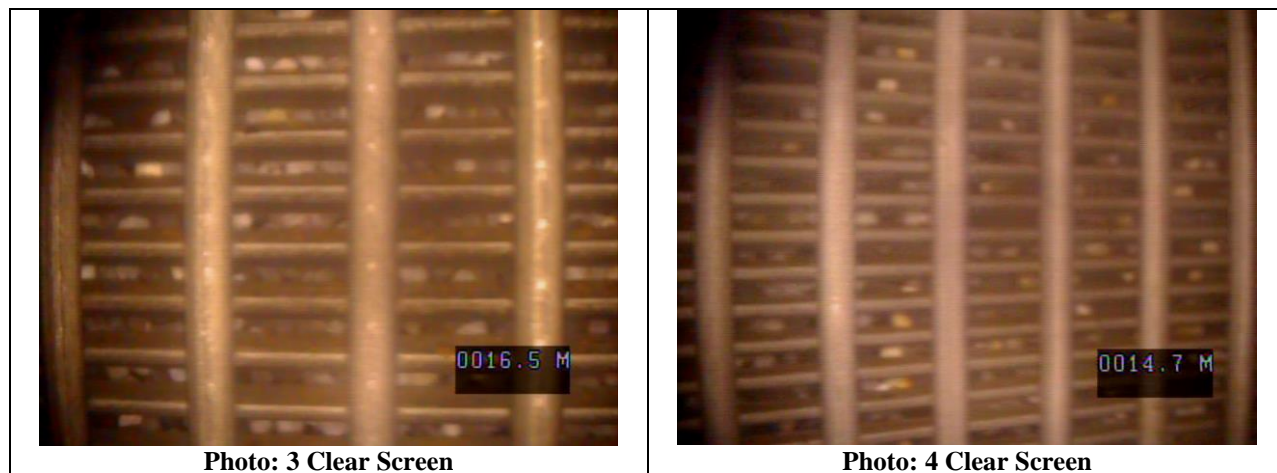
A post-rehabilitation pumping video was completed June 18, 2019. Significant well construction details are noted in **Table 2**. A DVD copy of the video has been enclosed with the original hard copy of this report. The video showed the rehabilitation has removed all of the fouling that was present on the well screen (**Photos 3 and 4**).

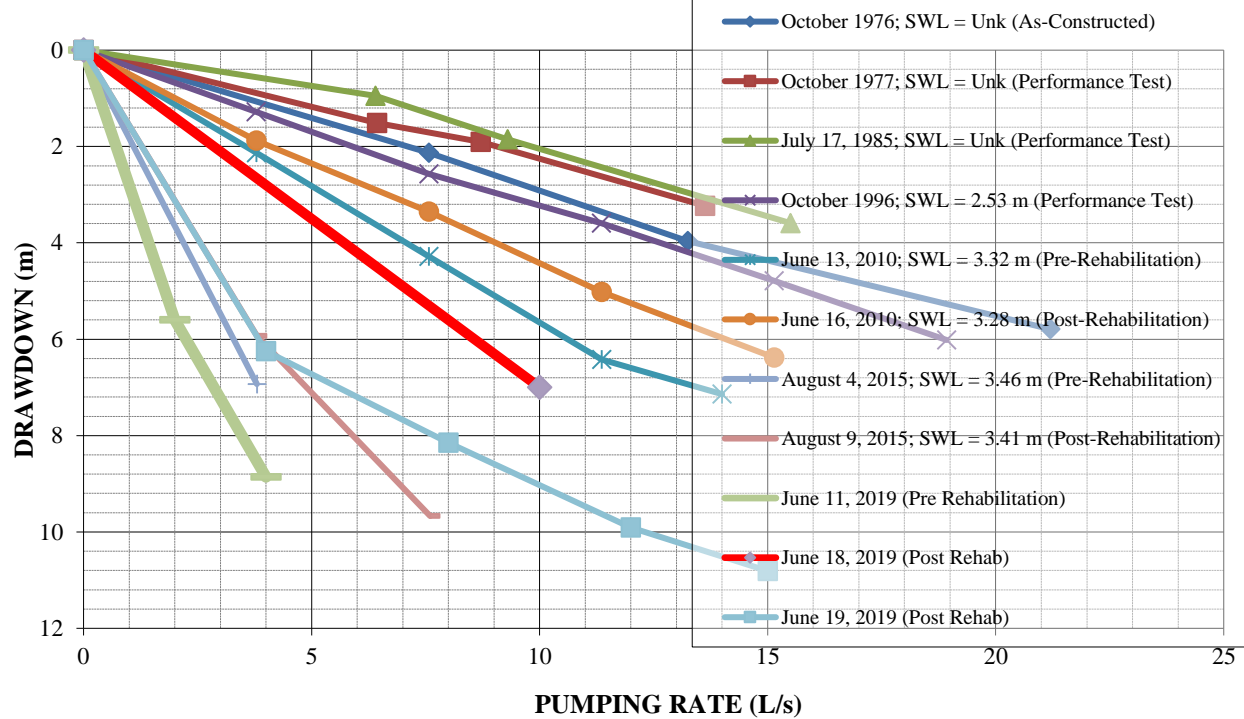
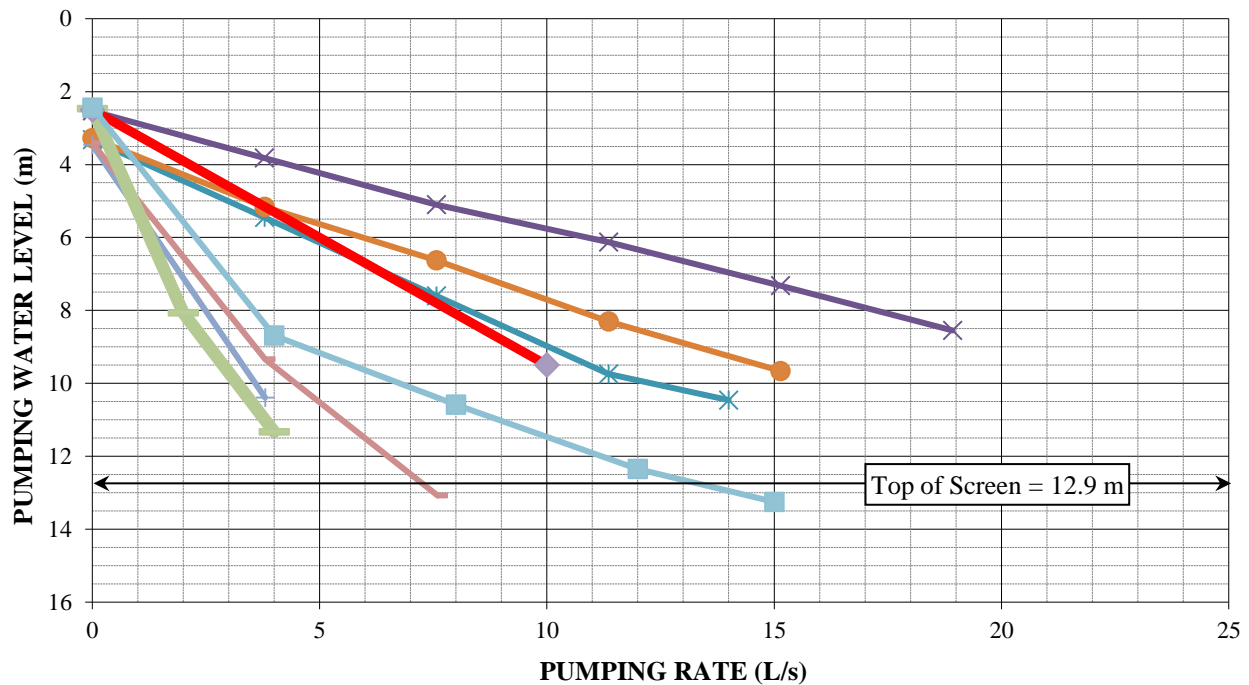
A post-rehabilitation well performance test was conducted on June 18, 2019. The data collected is provided in **Table 3** and was plotted graphically and compared against historical pumping levels on **Figure 1**. The post-rehabilitation test results indicate well performance has improved from a specific capacity of 0.62 L/s/m to 1.53 L/s/m. The wells maximum sustainable pumping rate has increased from approximately 6 to 14 L/s.

All water levels are referenced from top of casing
 Top of casing = 0.22 m above floor

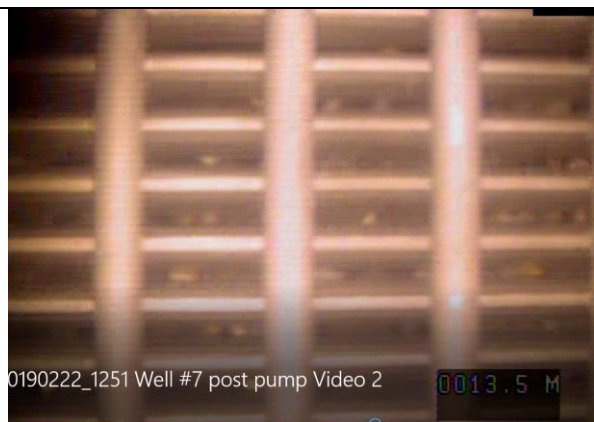
Photo 5: Screen Clean at 13.5 m

A post-rehabilitation static video was completed June 26, 2019. Significant well construction details are noted in **Table 2**. A DVD copy of the video has been enclosed with the original hard copy of this report. The video showed the rehabilitation has removed nearly all the fouling that was present on the well screen (**Photos 5 and 6**).
